## ACCIDENT INVESTIGATION

1. Accident report number:	25/011
2. Has the accident report for been completed?	Yes
3. If so by whom?	Andrew Loughlin-Smith – Day Manager
4. Have witness statements been taken?	Yes
5. Has CCTV been obtained?	Yes
6. Have all necessary documents been obtained?	Yes
7. Accident date:	25.11.24
8. Accident time:	05:40
9. Accident location:	Position 1 on the tipping lane

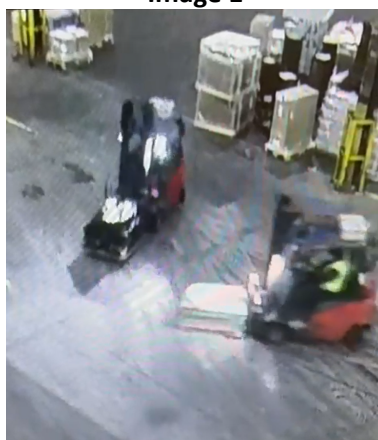
Image 1

On the 25<sup>th</sup> of November 2024 at 05:40, Pawel Pluta (FLT operative) was travelling in their lift truck (48) towards the tipping lane. As they were doing so, Lewis Watkins (FLT operative) on lift truck (24) was exiting a bay and was also heading towards the tipping lane. (See Image 1)

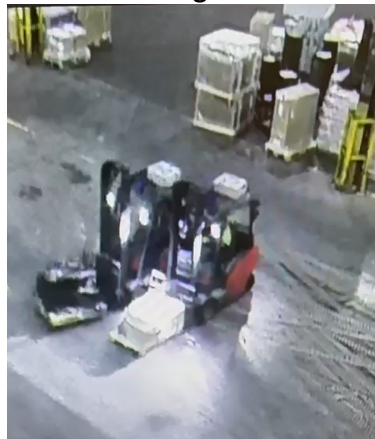
Image 2

Both drivers realised that they were on a collision course and attempted to turn away from each other, unfortunately, due to the grit that had been used on the roads across the country to counter the snow / ice, the hub floor had become slippery which meant that the trucks collided. (See Image 2)

As stated above the hub floor was slippery at the time of the collision, this is despite intense cleaning to remove the 'grit' that had been brought in by the visiting vehicles from the surrounding public highways. Due to the 'drive through' nature of the hub operation, water is brought into the building from vehicles and lift truck operatives are expected as taught in basic and refresher training to always drive to the conditions. Had either Mr Pluta or Mr Watkins been driving to the conditions, then this collision would have been avoided. To reiterate this point, the day shift moved in excess of 6000 pallets through the course of the 25<sup>th</sup> of November 2024, and no other incidents or collisions occurred.

Section 4b: Causation (continued)	
1. Why was the action committed?	Both operatives involved were operating their lift trucks, moving freight on the day shift.
2. Why did the condition exist?	Grit that had been used on the roads across the country to counter the snow / ice, the hub floor had become slippery
3. What was the root cause of the incident?	The hub floor was slippery at the time of the collision, this is despite intense cleaning to remove the 'grit' that had been brought in by the visiting vehicles from the surrounding public highways, but, had either Mr Pluta or Mr Watkins been driving to the conditions, then this collision would have been avoided.

Section 5: Recommendations and Actions			
Action item description	To be completed by	Review date	Status on review
1. Consider disciplinary action against both parties for failing to drive to the conditions.	Shift management.	12.12.24	
2. Continue to reiterate the need to drive to the conditions to all operatives.	Shift management.	12.12.24
